Manhole Inspection Summary

Manhole # S05UU1016MH

Location Address: **3402 HAMLIN AVE**

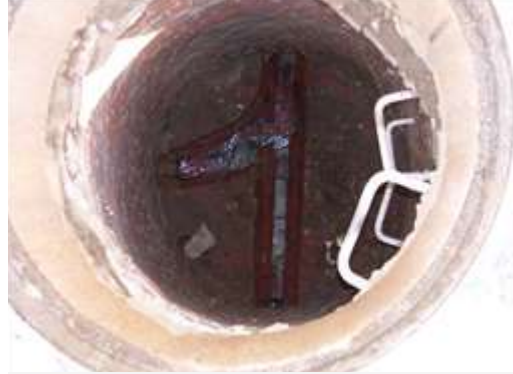
Top View

Frame leaks. Adjustment deterioration and loose brick. Adjustment, Corbel, and Barrel infiltration. Evidence of surcharge -

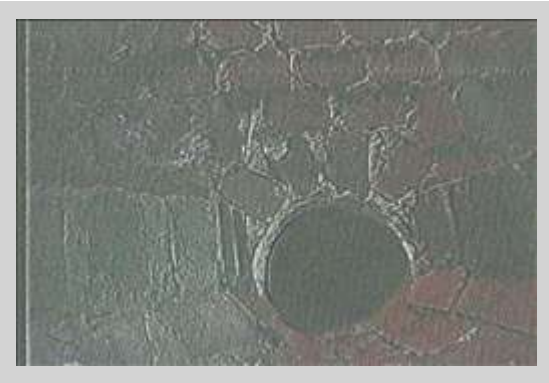
8 in. Circular Gravity Sewer Pipe Out @ 12 O'Clock

Barrel deterioration and infiltration. Channel deterioration.

Infiltration: **Evidence** Pipe Seal Cond: **Cracked**

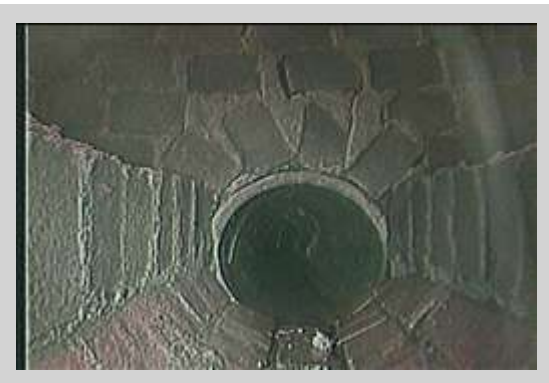
8 in. Circular Gravity Sewer Pipe In @ 6 O'Clock

Barrel deterioration and infiltration. Channel deterioration.

Infiltration: **Evidence** Pipe Seal Cond: **Unknown**

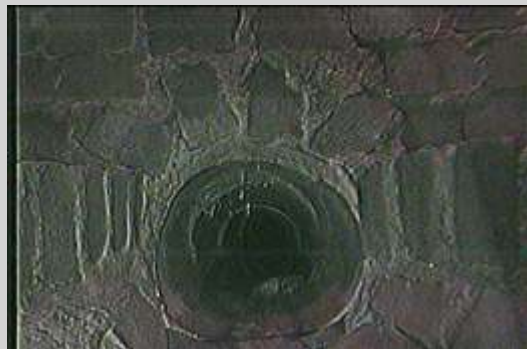
Pipe In @ 9 O'Clock

Barrel deterioration and infiltration. Channel deterioration.

Infiltration: **Evidence** Pipe Seal Cond: **Unknown**
